### **URGENT: MEDICAL DEVICE COMMUNICATION**

#### **HeartWare™ Ventricular Assist Device (HVAD™) System: Communication update regarding failure/delay to restart pump events**

August 23, 2023

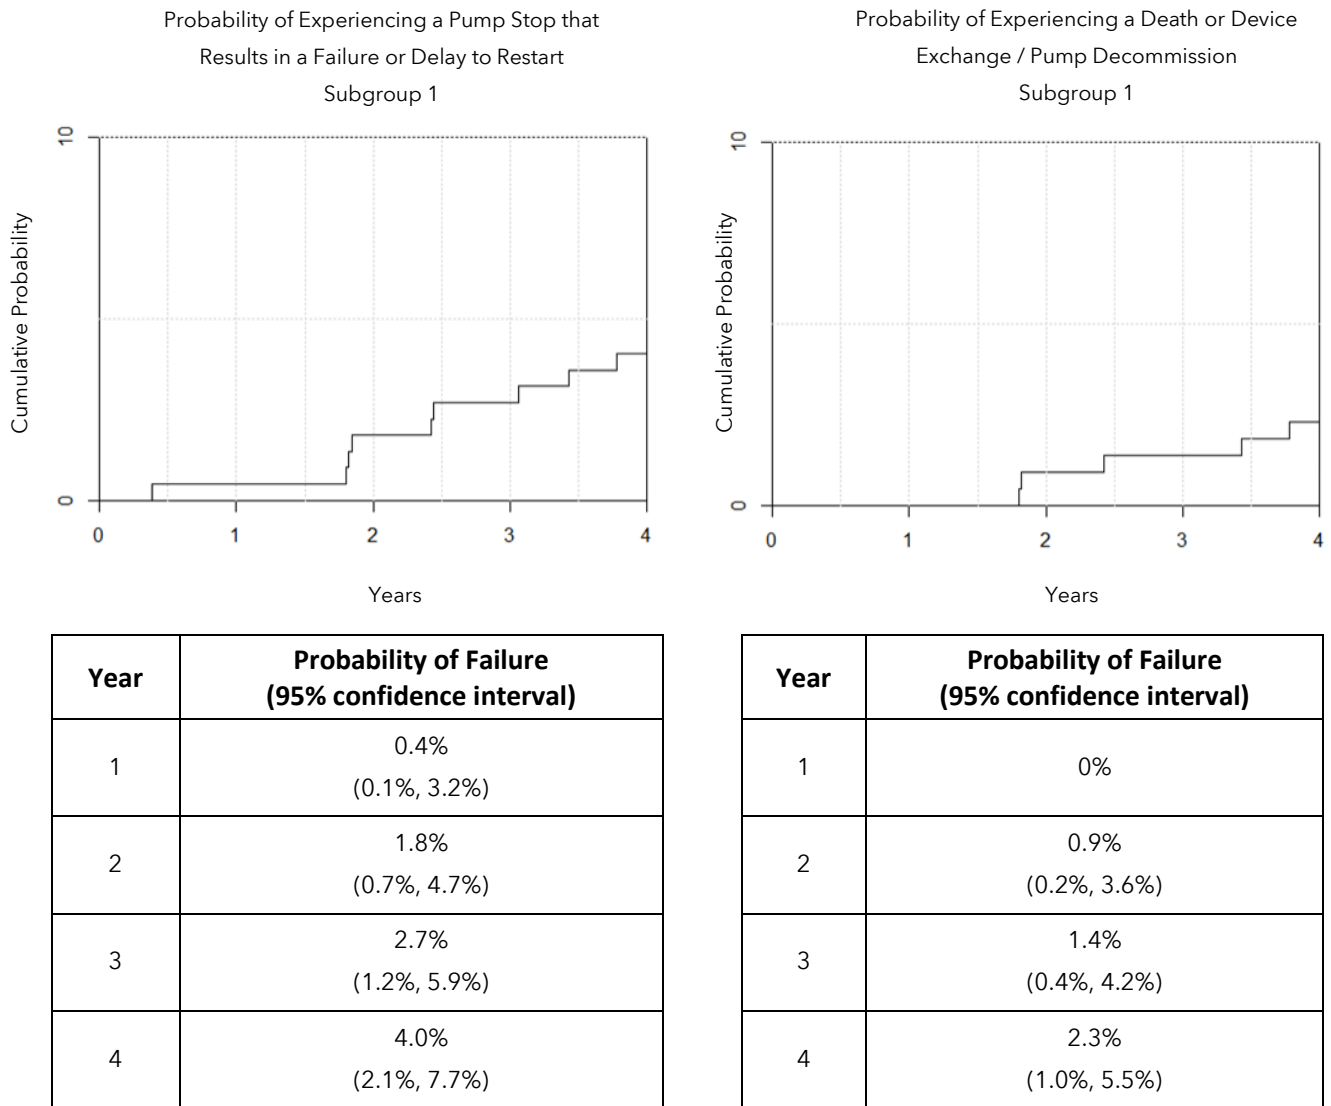
**Figure 1: Cumulative incidence of experiencing a pump stop with delay/failure to restart (left) and the cumulative incidence of failures leading to a pump exchange or death (right) in Subgroup 1.**

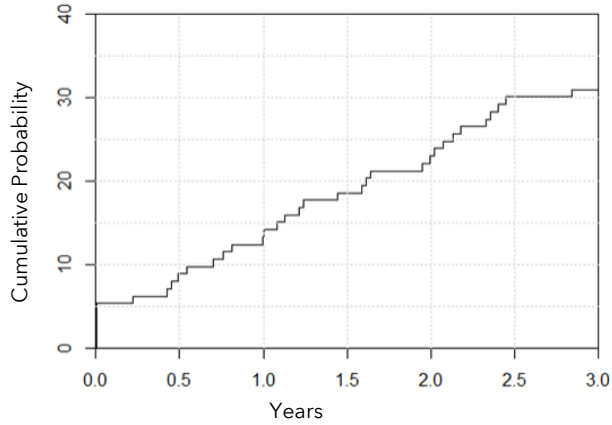
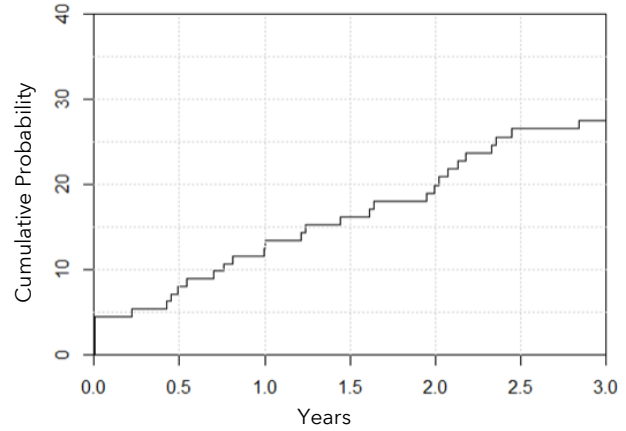
Year	Probability of Failure (95% confidence interval)
1	13.3% (8.3%, 21.3%)
2	23.0% (16.4%, 32.2%)
3	31.0% (23.5%, 40.8%)

Year	Probability of Failure (95% confidence interval)
1	12.5% (7.6%, 20.3%)
2	19.9% (13.7%, 29.0%)
3	27.5% (20.3%, 37.4%)

**Figure 2: Cumulative incidence of experiencing a pump stop with delay/failure to restart (left) and the cumulative incidence of failures leading to a pump exchange or death (right) in Subgroup 2.**

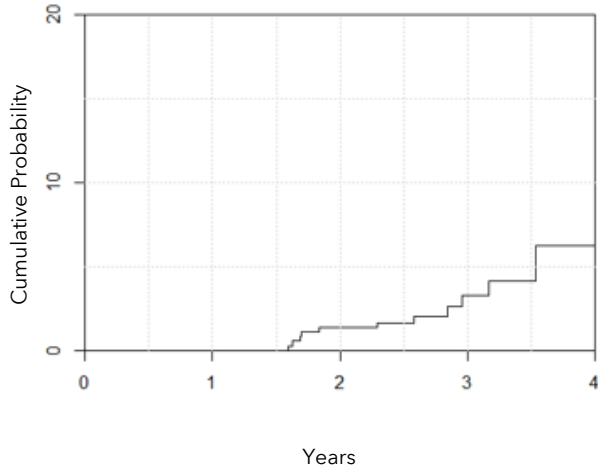
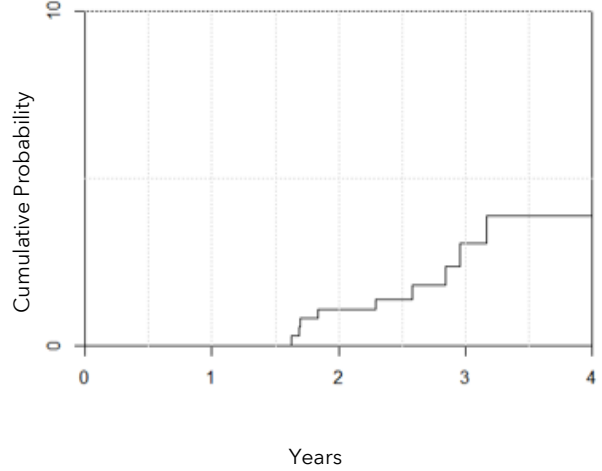
Year	Probability of Failure (95% confidence interval)
1	0%
2	1.3% (0.6%, 3.2%)
3	3.3% (1.7%, 6.6%)
4	6.2% (2.9%, 13.3%)

Year	Probability of Failure (95% confidence interval)
1	0%
2	1.1% (0.4%, 2.8%)
3	3.0% (1.5%, 6.3%)
4	3.9% (1.9%, 7.9%)

**Figure 3: Cumulative incidence of experiencing a pump stop with delay/failure to restart (left) and the cumulative incidence of failures leading to a pump exchange or death (right) in Subgroup 3.**

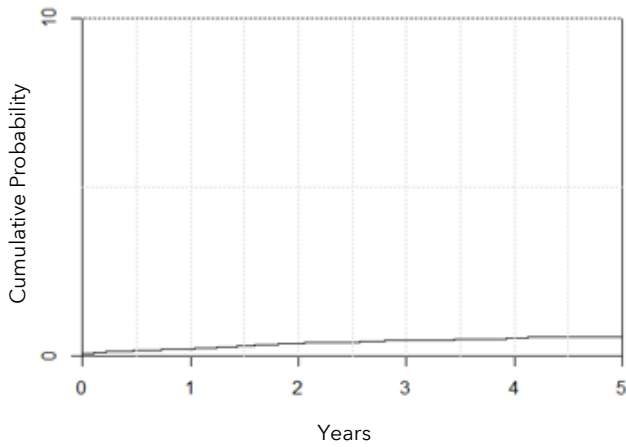
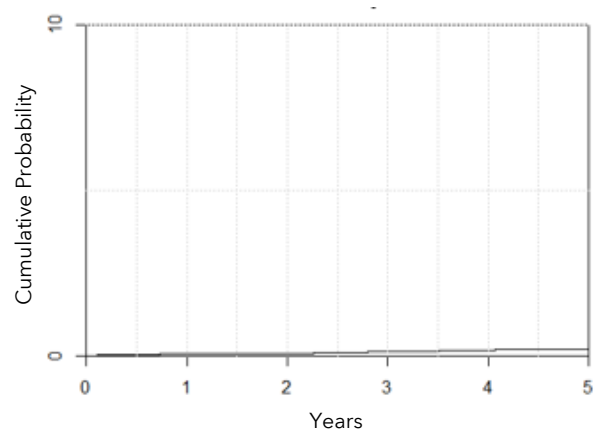
Year	Probability of Failure (95% confidence interval)
1	0.2% (0.1%, 0.3%)
2	0.4% (0.3%, 0.5%)
3	0.5% (0.3%, 0.6%)
4	0.5% (0.4%, 0.7%)
5	0.5% (0.4%, 0.7%)

Year	Probability of Failure (95% confidence interval)
1	0.04% (0.01%, 0.1%)
2	0.05% (0.02%, 0.1%)
3	0.1% (0.07%, 0.2%)
4	0.2% (0.1%, 0.3%)
5	0.2% (0.1%, 0.3%)

**Figure 4: Cumulative incidence of experiencing a pump stop with delay/failure to restart (left) and the cumulative incidence of failures leading to a pump exchange or death (right) in the general population.**
