URGENT: Medical Device Recall Notification AFFECTED DEVICE: BD Alaris™ System

February 4, 2020

BD Alaris™ System PC Unit Model 8015, software version 12.1.0 BD Alaris™ Pump Module Model 8100, software version 12.1.0 Alaris™ Syringe Module Model 8110, software version 12.1.0 Alaris™ PCA Module Model 8120, software version 12.1.0

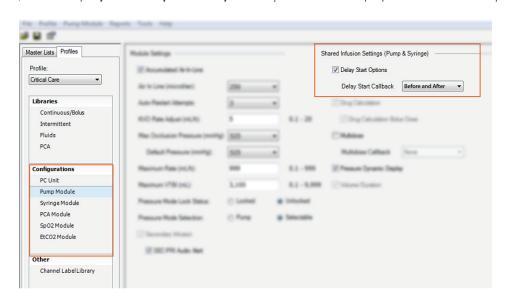
Clinical scenario: Patient's blood sugar is 65 mg/dL and the physician orders to hold insulin drip for 45 minutes, then recheck and resume if above 80 mg/dL. Clinician sets a delay for 45 minutes with a callback BEFORE. The clinician resumes the infusion. When the infusion completes—the infusion will STOP. There is NO KVO rate and an alarm **will not** occur for device firmware versions 9.19 and earlier.

- Disable Delay Start Options for care area profiles that utilize continuous critical medications whose stoppage without an alarm or KVO rate have the potential to impact therapeutic dosing.
- If Delay Start is enabled—set default Delay Start Callback of "After" or "Before and After" to receive an end of infusion alarm when the infusion stops. If a callback of "None" or "Before" is selected, the end of infusion status may result in the infusion ending with NO alarm and NO KVO rate.

Disable Delay Start Options—uncheck Delay Start Options checkbox

Adjust Delay Start default callback options—select "**After**" or "**Before and After**" from the drop-down box if Delay Start Options is enabled.
