URGENT SAFETY COMMUNICATION

December 29, 2021

Problem Description Baxter is communicating important safety information for Spectrum V8 and Spectrum IQ infusion pumps related to potential reduced or non-delivery of medication, in some cases without alerting the user via pump alarm. This may occur as a result of incorrect administration set setup and/or incomplete resolution of upstream occlusion alarms when using Spectrum V8 and Spectrum IQ infusion pumps.

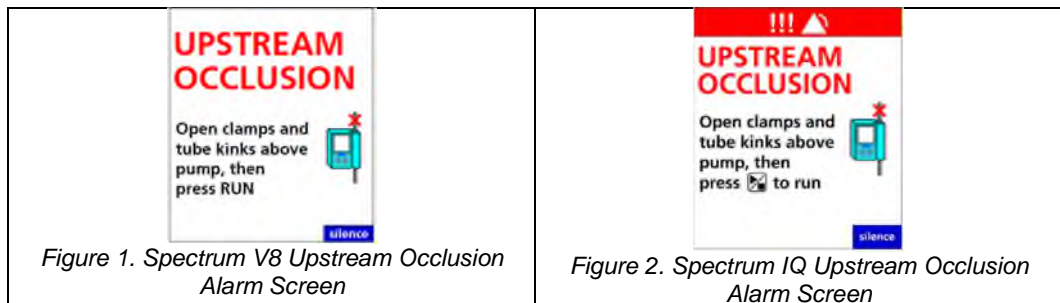
After an upstream occlusion alarm, failure to fully resolve any upstream occlusion before restarting the pump can cause the pump to not re-alarm as expected. The pump adjusts occlusion detection after the user acknowledges an upstream occlusion alarm; for the remainder of that infusion, the upstream occlusion alarm will not alarm per its baseline settings. If an upstream occlusion persists after the clinician does not fully resolve the occlusion, the alarm may not recur as expected. The risk is particularly higher when infusing with flow rates below 5 ml/hr. **WARNING: If an upstream occlusion remains after the RUN/STOP key is pressed, the pump may appear to be infusing normally, though it may be infusing below the programmed rate or not infusing at all.** Therefore, **do not press the RUN/STOP key prior to inspecting the IV set line and resolving the occlusion** (refer to Figures 1 and 2 below). This adjustment only affects the current therapy session, as the occlusion detection is reset each time an infusion is started.

6. When responding to an upstream occlusion alarm, **do not press the RUN/STOP key prior to inspecting the IV tubing and resolving any occlusions**, as described above. If an upstream occlusion is not fully cleared above the pump and/or within the pumping channel, an upstream occlusion alarm may not reoccur.
