Urgent Medical Device Correction

HeartWare™ Ventricular Assist Device (HVAD™)

Model	Product Description
1103	HVAD™ Pump Implant Kit
MCS1705PU	HVAD™ Pump Implant Kit

April 2022

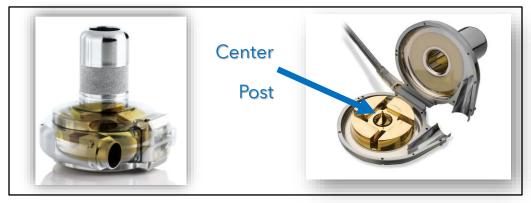
Figure 1: Pump Assembly

Medtronic is writing to inform you that we are investigating a new issue with the HeartWare™ Ventricular Assist Device (HVAD™) System. Medtronic has received three (3) complaints of patients with suspicion of pump thrombosis; however, a device malfunction was identified upon inspection of the three (3) returned pumps. Wear marks indicated that the impeller was rotating non-concentrically and contacting the center post of the pump (see Figure 1 Pump Assembly). The ongoing investigation suggests this was caused by a weld defect that allowed moisture into the center post and corroded the magnets that keep the impeller rotating concentrically.

Routine prophylactic explant of the HVAD device is not recommended, as risks associated with explantation may outweigh the potential benefits. Physicians should make the decision regarding explant and exchange of the HVAD pump on a case-by-case basis (is the patient a candidate for pump exchange, heart transplant, or pump explant for recovery), considering the patient's clinical condition and surgical risks.

For patients presenting with any of the above signs and symptoms consider whether the clinical presentation could be due to a pump thrombus and treat accordingly. Please ensure the .csv logfiles are submitted to Medtronic for review.
