## Urgent Medical Device Correction

### Pump Weld Update for HeartWare™ Ventricular Assist Device (HVAD™)

Model	Product Description
1103	HVAD™ Pump Implant Kit
MCS1705PU	HVAD™ Pump Implant Kit

26 July 2022

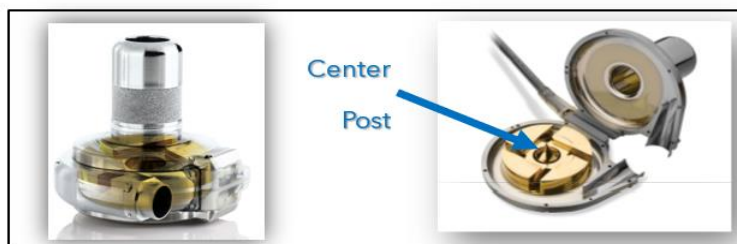
**Figure 1: Pump Assembly**

Medtronic is providing this letter as a follow-up to our April 2022 communication titled “Urgent Medical Device Correction” (attached), which communicated a pump weld non-conformance with the HeartWare™ Ventricular Assist Device (HVAD™) System where (3) pumps were identified to have an impeller rotating non-concentrically and contacting the center post of the pump (see Figure 1: Pump Assembly). Medtronic’s investigation was not able to conclusively isolate this issue to a specific subset of pumps. This communication provides updated information on the number of events, additional event details, and root cause.

The investigation has determined that the occurrence of a weld crack is the result of a combination of factors that may include the initial presence of contamination in the weld area from previously applied substances as part of the manufacturing process, the misalignment of the cap and housing prior to welding, or the depth/thickness of the weld. Medtronic’s investigation employed multiple methods to isolate the issue to a specific subset of pumps including quantifying weld thickness, alignment indicators, and visual indications of contamination using over 8000 digital photos. Medtronic has found that there is not enough data available to conclusively isolate this issue to a specific subset of pumps.

Consistent with the April 2022 communication, routine prophylactic explant of the HVAD device is not recommended, as risks associated with explantation may outweigh the potential benefits. Physicians should make the decision regarding explant and exchange of the HVAD pump on a case-by-case basis (is the patient a candidate for pump exchange, heart transplant, or pump explant for recovery), considering the patient’s clinical
