URGENT MEDICAL DEVICE COMMUNICATION

HeartWare™ Ventricular Assist Device (HVAD™) System

Model	Geography
1103	US

December 2021

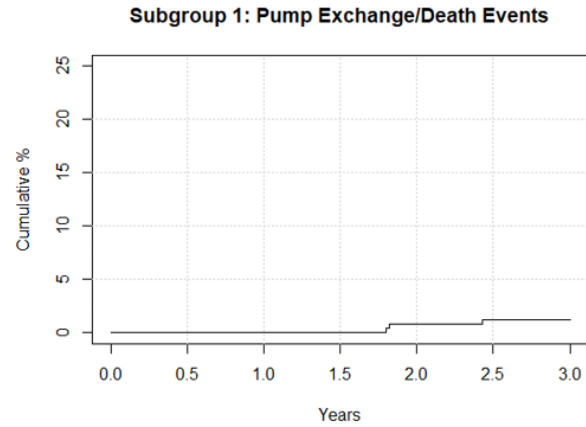
Year	Rate	Lower CI	Upper CI
1	0	NA	NA
2	0.8%	0.2%	3.2%
3	1.2%	0.4%	3.8%

Figure 1: Cumulative incidence of experiencing a pump stop with delay/failure to restart leading to a pump exchange or death in Subgroup 1

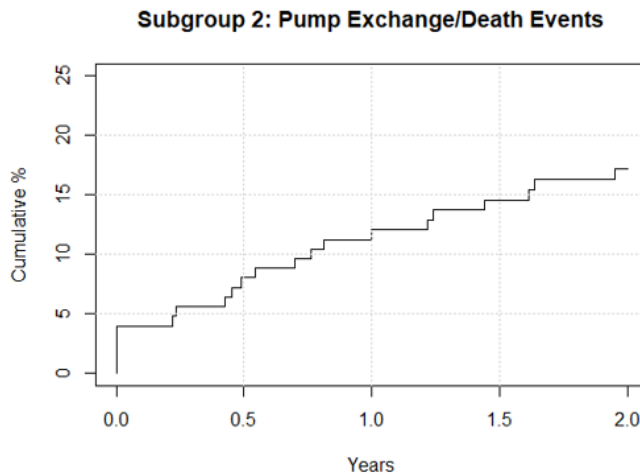
Year	Rate	Lower CI	Upper CI
1	12.1%	7.5%	19.4%
2	17.2%	11.7%	25.5%

Figure 2: Cumulative incidence of experiencing a pump stop with delay/failure to restart leading to a pump exchange or death in Subgroup 2
